# Placer County/Town of Truckee

## Final Joint Annual Monitoring Report for:

### Implementation of the Truckee River Water Quality Monitoring Plan

Water Year 2012

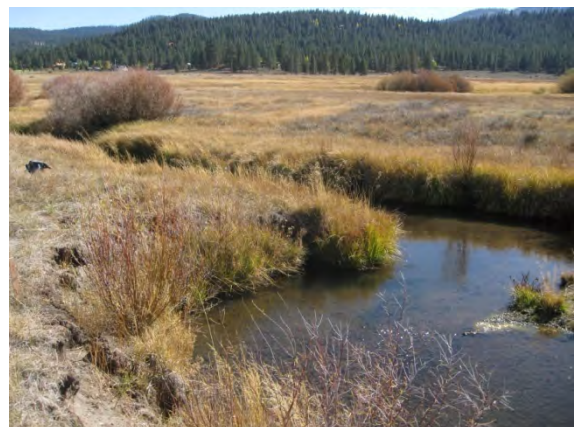
**Figure 1-1**  
**Martis Creek Main Stem**  
**September 2012**

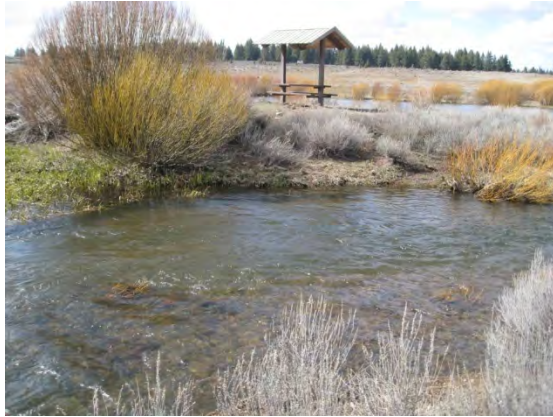
**FIGURE 4-7a.** DST-MC1 monitoring location on Martis Creek near Martis Creek Lake.

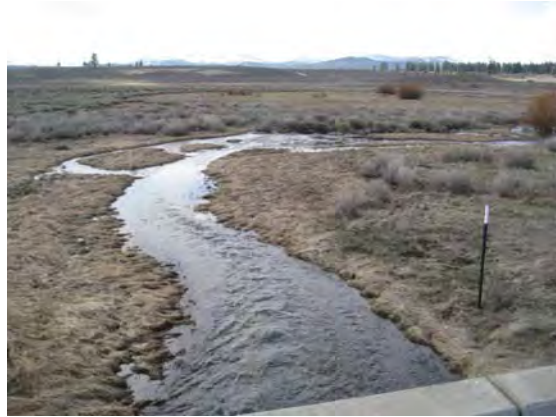
**FIGURE 4-7b.** DST-MC2 monitoring location on East Martis Creek.

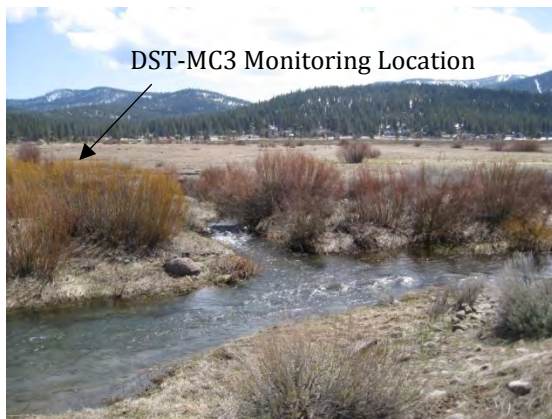
**FIGURE 4-7c.** Middle Martis Creek confluence. DST-MC3 monitoring location is just upstream.

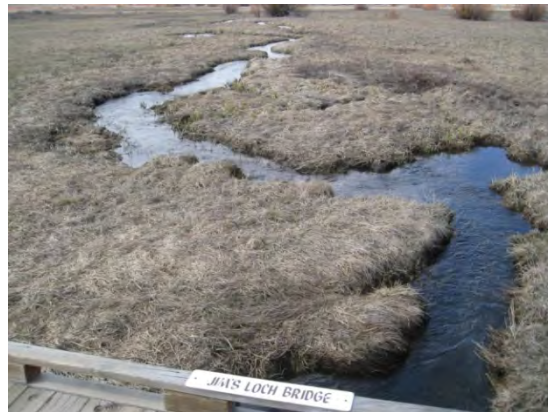
**FIGURE 4-7d.** DST-MC4 monitoring location on West Martis Creek.

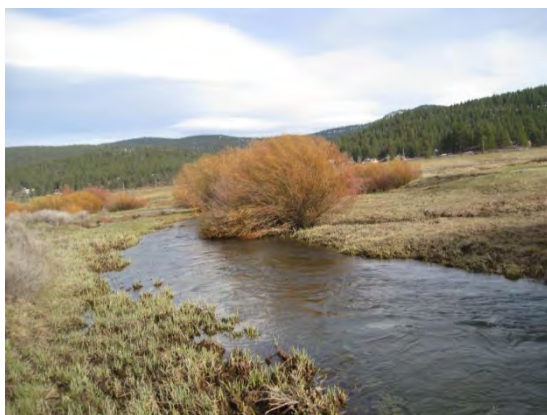
**FIGURE 4-7e.** DST-MC5 monitoring location is on Martis Creek just downstream of an unnamed tributary confluence.

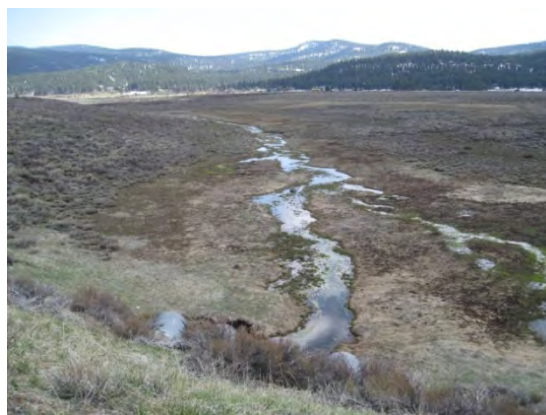
**FIGURE 4-7f.** DST-MC6 monitoring location on unnamed tributary near Martis Creek Road.

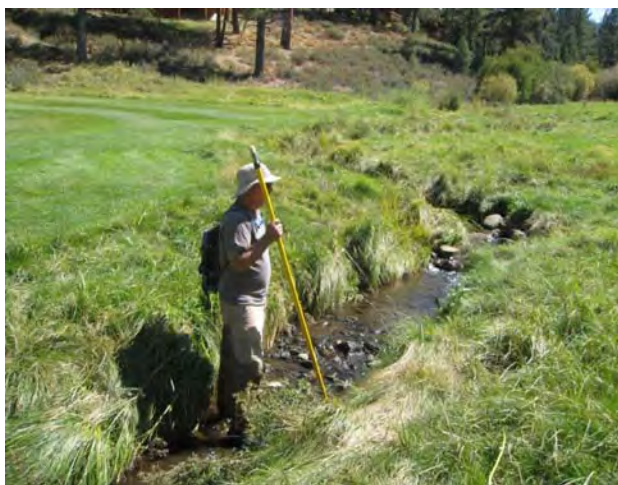
**Figure 5-2. Upper West Martis Creek: Example of Low Percentage Fine Sediment Substrate**

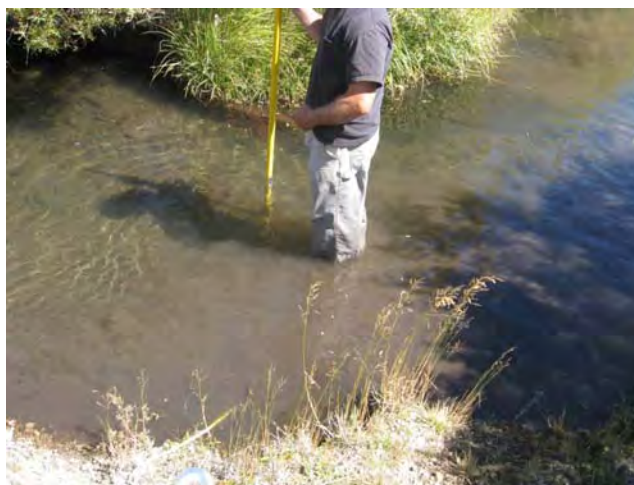
**Figure 5-3. Martis Creek: Example of High Percentage Fine Sediment Substrate**

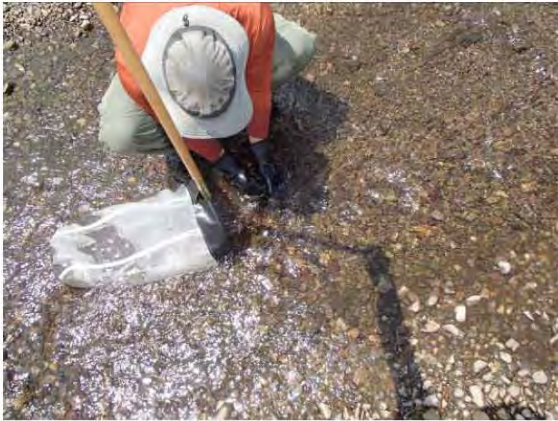
**FIGURE 5-27a.** Collecting benthic macroinvertebrate samples in Squaw Creek (7/23/12).

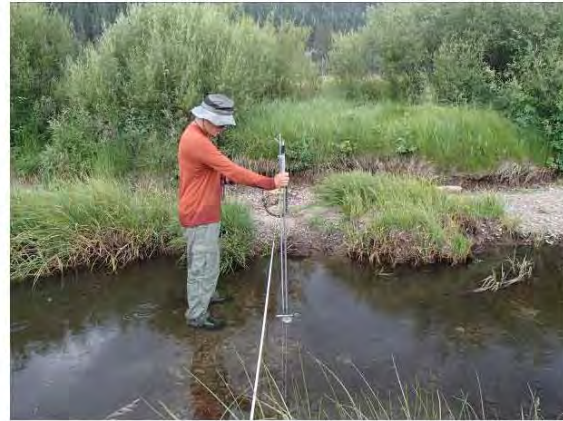
**FIGURE 5-27b.** Measuring stream discharge in Squaw Creek (7/23/12).

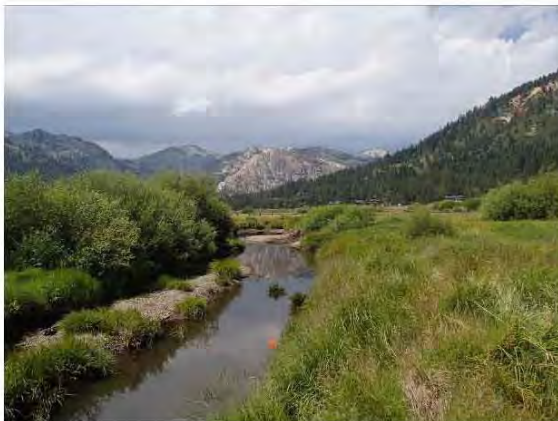
The channel in this meadow section of Squaw Creek is very low gradient (0.01% to 0.35% slope) with relatively high sinuosity (1.1 to 1.9). The channel is typically open and un-shaded (mean canopy cover was between 0% and 1%). Stream banks are lined with low herbaceous cover (grasses, sedges, etc.) and sparse willow bushes. The channel appeared incised with a high percentage of eroded stream banks (69% to 88%). Several banks had boulder rip-rap placed as protection although some of this was failing.

**FIGURE 5-27c.** Looking upstream from the middle of the Lower Meadow site (7/23/12).

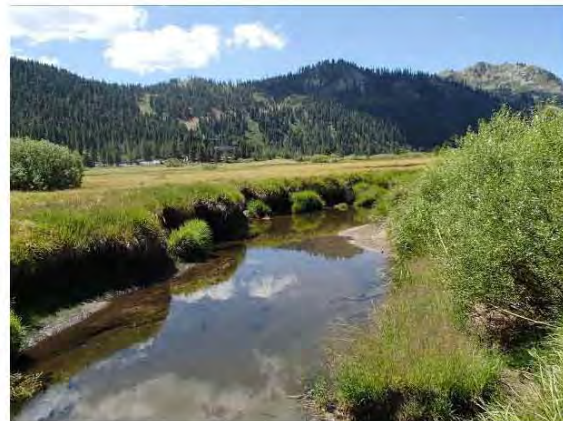
**FIGURE 5-27d.** Looking upstream from near the top of the Middle Meadow site (7/24/12).

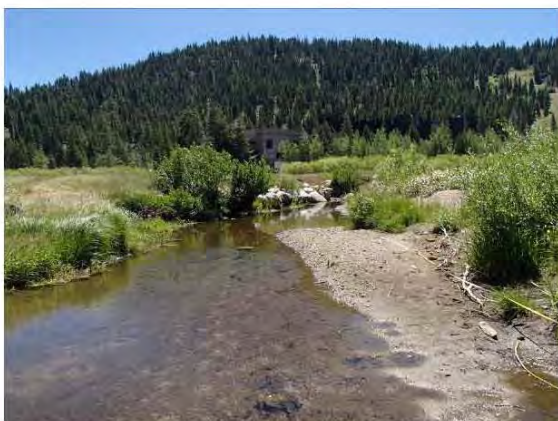
**FIGURE 5-27e.** Looking upstream from the middle of the Upper Meadow site (7/30/12).

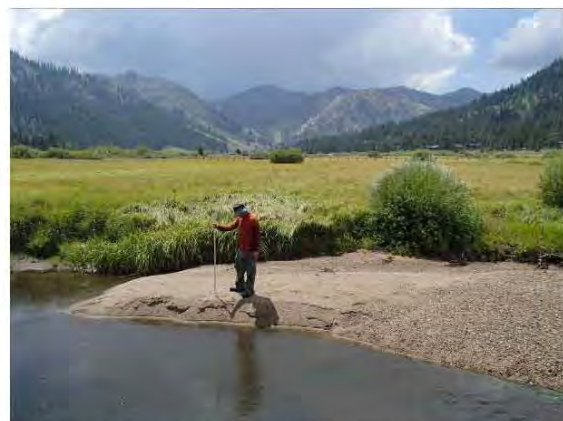
The results of the Squaw Creek bioassessments continue to indicate the predominance of DG sand and finer sediments in benthic habitat areas; however, the biological metrics for two of the three bioassessment reaches have improved since the previously conducted surveys in 2010. It is likely that Squaw Creek may have experienced fewer disturbances associated with reduced surface flows and intermittency during the summer of 2011. Snowmelt and saturated ground conditions from the record snowpack of the 2010-2011 winter likely sustained surface flows in Squaw Creek further into the summer and fall than usual in 2011, thereby allowing a more robust benthic community to develop during this period.

**FIGURE 5-27f.** Deposition of DG sand and fine sediments along the Lower Meadow site (7/23/12).

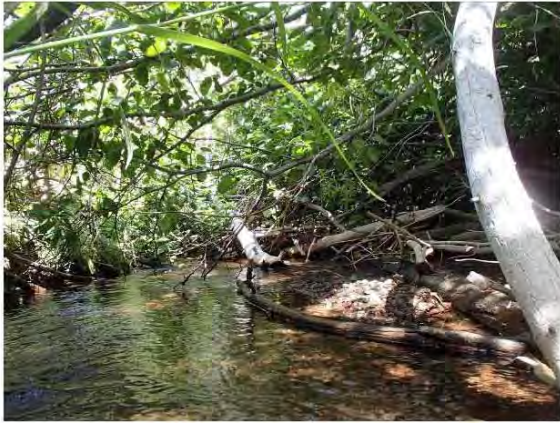
**FIGURE 5-28a.** Looking upstream from the bottom of site Bio-MC1 in the Schaeffer Branch (8/21/12).

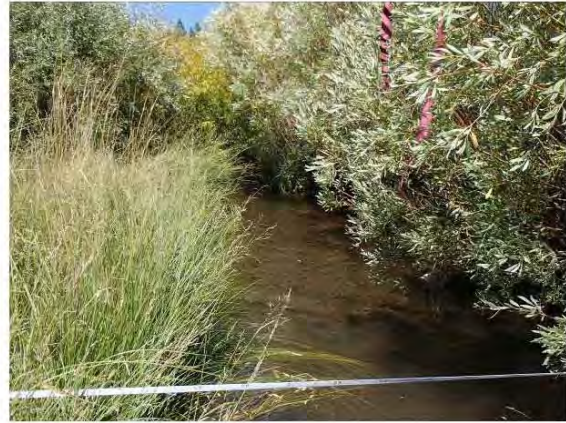
**FIGURE 5-28b.** Looking upstream from the bottom of site Bio-MC2 in middle Martis Creek (8/24/12).

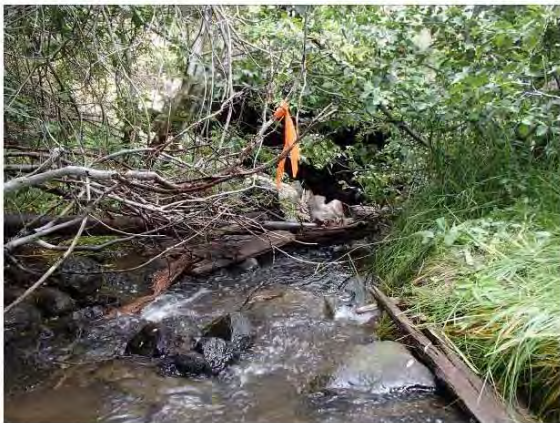
**FIGURE 5-28c.** Looking upstream from the bottom of site Bio-MC3 in the upper West Branch (9/6/12).

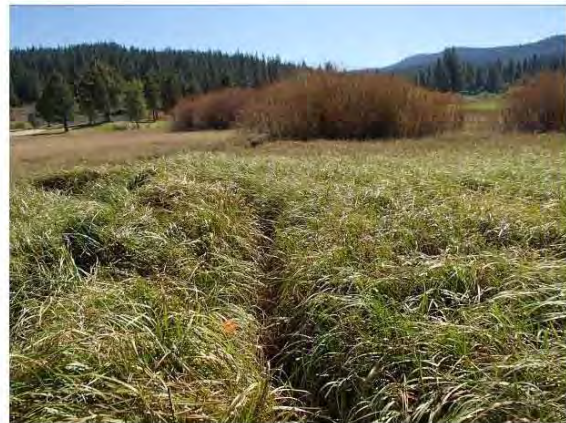
**FIGURE 5-28d.** Looking upstream from the bottom of site Bio-MC4 in the lower West Branch (9/17/12).

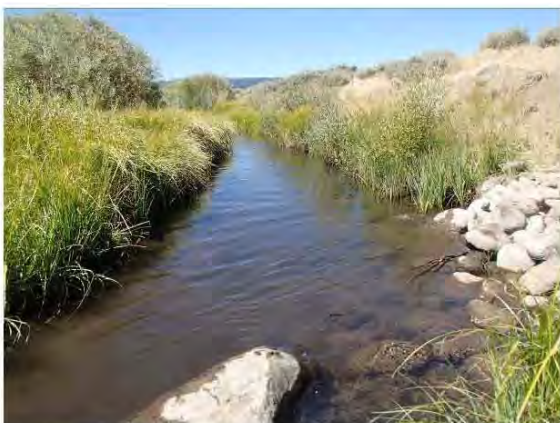
**FIGURE 5-28e.** Looking upstream from the bottom of site Bio-MC5 in lower Martis Creek (9/14/12).

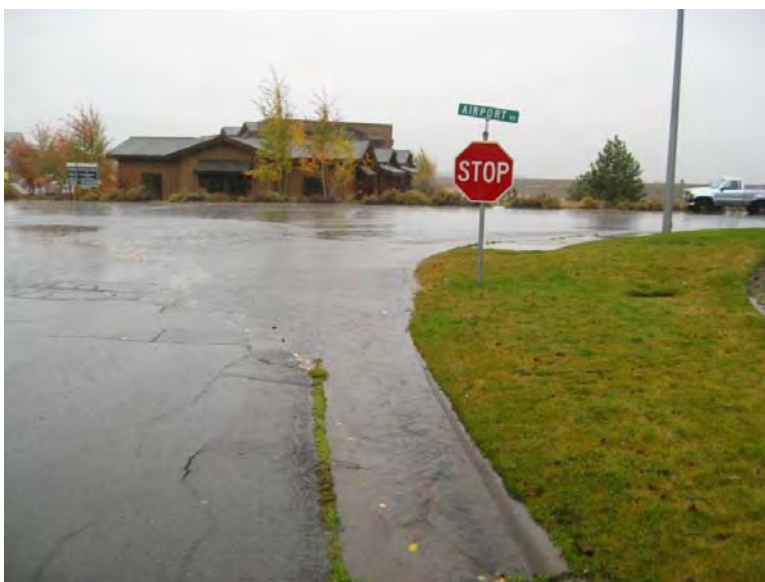
Much of the Airport Business Park drainage area consists of newer development which incorporates infiltration and settling basins, vegetated swales, and sediment traps. However, the drainage area also includes paved roadways with moderate traffic that are directly connected to the outfall with little to no treatment (see Figure 5-35). The low to moderate pollutant concentration levels observed at this site correlate well with the landuses and water quality improvements at this site.

**Figure 5-35**  
**Airport Business Park Drainage Area on October 24, 2010**

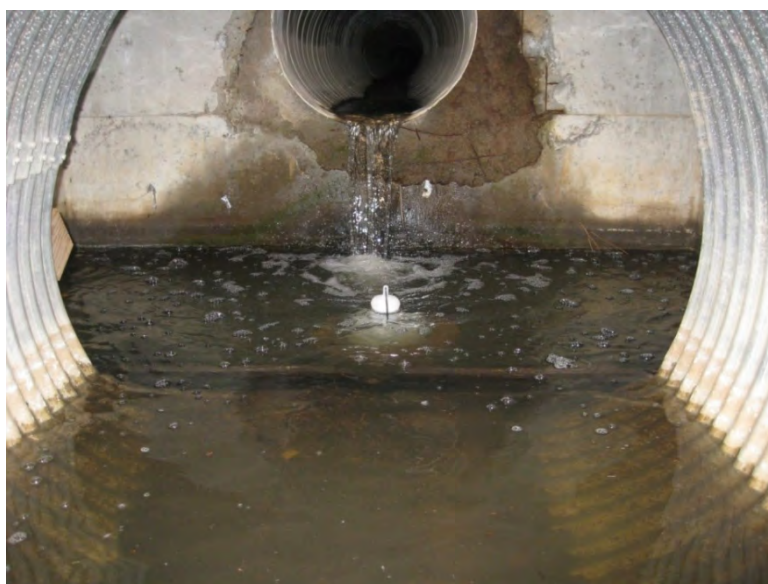
The water quality at the Airport Business Park site is also influenced by groundwater that infiltrates into the drainage system when the water table elevation rises. The groundwater appears to be very clean, and likely dilutes the stormwater runoff that is sampled (Figure 5-36). The groundwater is at its lowest rate in the fall, and the flow increases throughout the winter and spring. Monitoring at this site has been discontinued.

**Figure 5-36**  
**Airport Business Park Groundwater Intrusion on November 5, 2012**

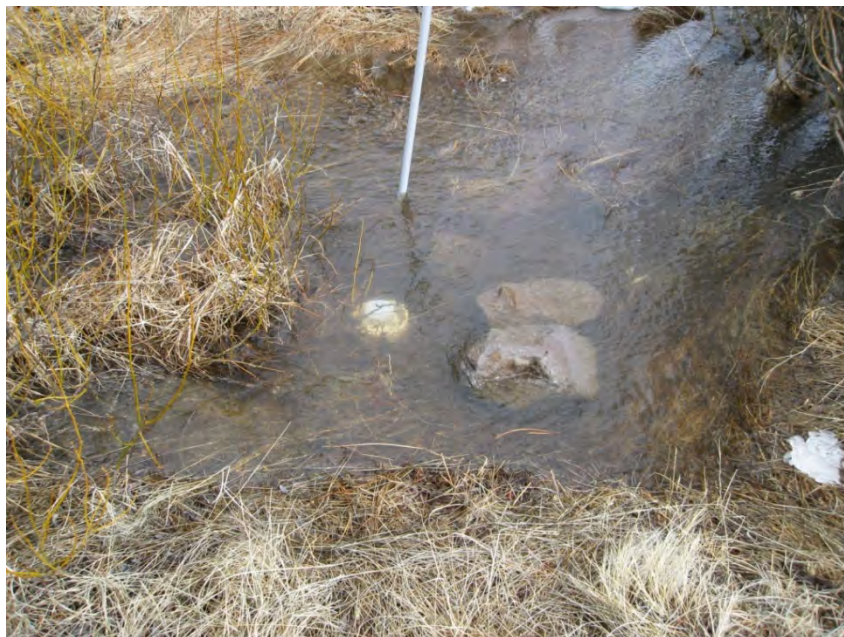
Two years of data at this site indicate it has the lowest mean values for TSS, turbidity, total phosphorus, and total nitrogen. The drainage area consists of modern development that includes a golf course and residential area with minimal impervious area. This community also includes facilities that treat stormwater runoff prior to discharge including a long vegetated channel. The sampling location is within a drainage channel that experiences a large amount of continuous baseflow in the winter and spring as shown in Figure 5-37. The baseflow appears to be very clean, and likely dilutes the stormwater runoff that is sampled. In the summer and fall when no baseflow exists, runoff tends to infiltrate prior to reaching the sampling location unless the event is very large (Figure 5-38).

**Figure 5-37**  
**Baseflow at the Lahontan Site on March 14, 2012**

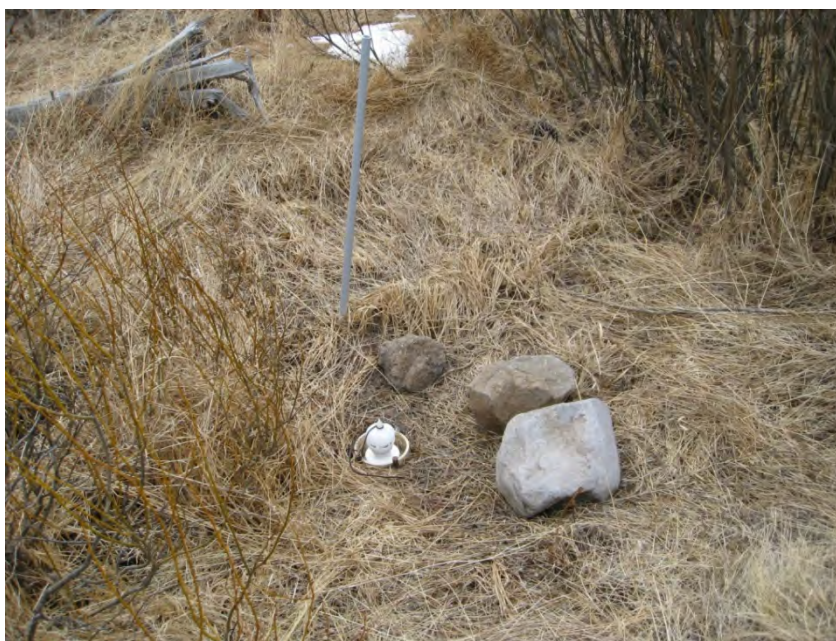
Unusually high nutrient concentrations were observed during one large event on January 20, 2012 when no baseflow existed. This could be attributed to the amount of decaying vegetation that existed in the channel at this time (Figure 5-38) or possibly by fertilizer applications on the upstream golf course.

**Figure 5-38**  
**Dry Conditions at the Lahontan Site on January 18, 2012**

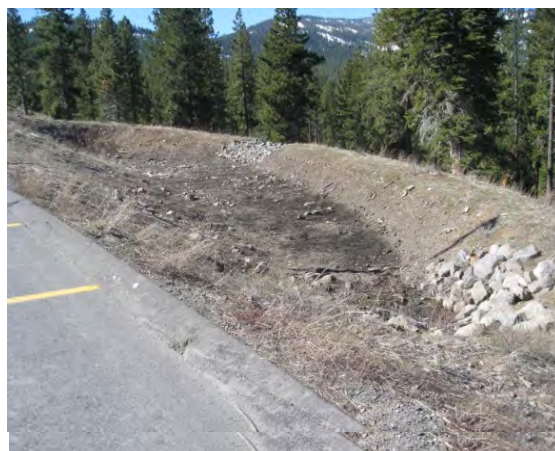
**Figure 5-39**  
**Infiltration/Sedimentation Basin at Northstar**

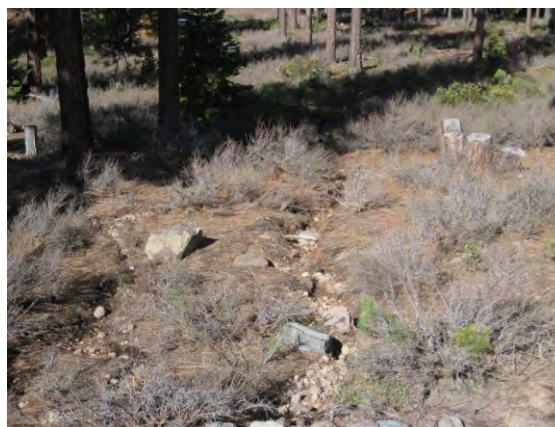
**Figure 5-40**  
**Erosion Downstream of**  
**Infiltration/Sedimentation Basin**

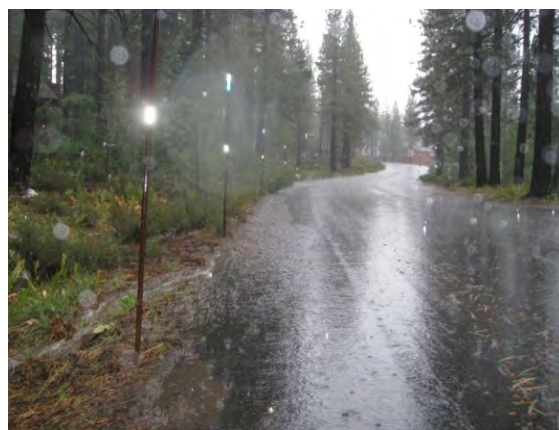
**Figure 5-41**  
**High Flow Rates at Northstar Site during**  
**Thunderstorm on August 14, 2012**

concentration levels when compared to other community sites. This is in large part attributed to one intense Thunderstorm event that was sampled on August 14, 2012. This sample had the highest concentrations of pollutants observed to date. During this event, the upstream infiltration basin filled completely, and high flow rates were observed on the residential street (Skidder Trail) as shown in Figure 5-41.

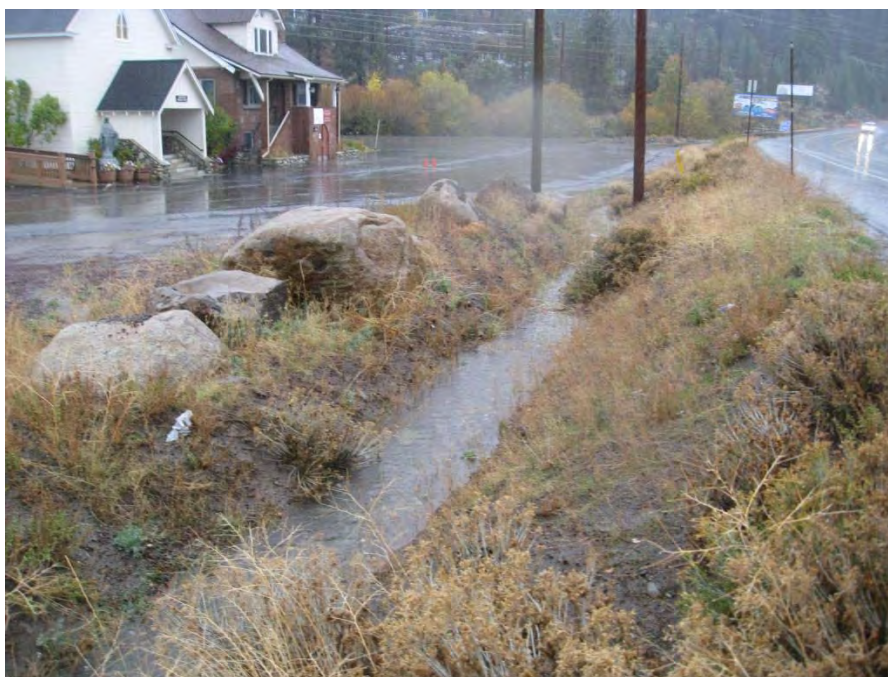
The Trout Creek drainage area includes portions of the oldest parts of downtown Truckee and includes a high percentage of impervious area with commercial and residential activities and large parking areas. Most of these areas drain to a stable vegetated channel (Figure 5-42) and then through a stormwater treatment vault prior to discharging to Trout Creek. Localized sheet flow from a portion of Donner Pass Road enters a similar vegetated channel on the opposite side of the roadway where flow has been observed to be minimal. The combination of these factors explain the relatively low TSS and turbidity concentrations observed in the samples from this site. Field observations also indicate that the vegetated swale infiltrates a significant portion of the runoff. Some samples have contained higher nutrient concentrations which may be a result of decomposing vegetation in the earthen channel, fertilizer use for landscaping, and wildlife (raccoons) which have been observed in the storm drain system upstream of the sample location. One unusually high total phosphorus concentration was observed during a large rain event on October 4, 2010.

**Figure 5-42**  
**Vegetated Channel Draining Towards the Trout Creek SE Outfall (DSC-TC1)**

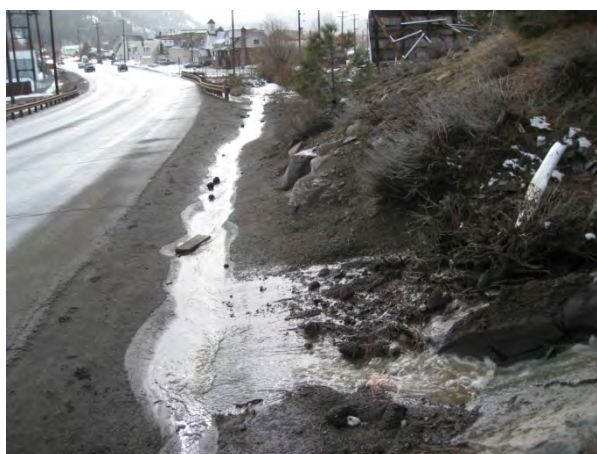
This site was installed in March 2012 and monitored for TSS, turbidity, pH, and conductivity only. TSS was laboratory analyzed, but the other constituents were measured using field instruments. The catchment area for this site includes the recent Stoneridge multifamily development, a Caltrans maintenance station and high traffic roads and intersections that receive frequent traction sand treatment during winter months. Runoff travels through a series of earthen and paved swales with no treatment prior to discharging to Trout Creek. A steep rocky channel conveys flows from Jiboom Street onto the asphalt shoulder of Donner Pass Road where it is conveyed to the outfall (Figures 5-43 and 5-44).

**Figure 5-43**  
**Asphalt Swale Leading to Trout Creek**

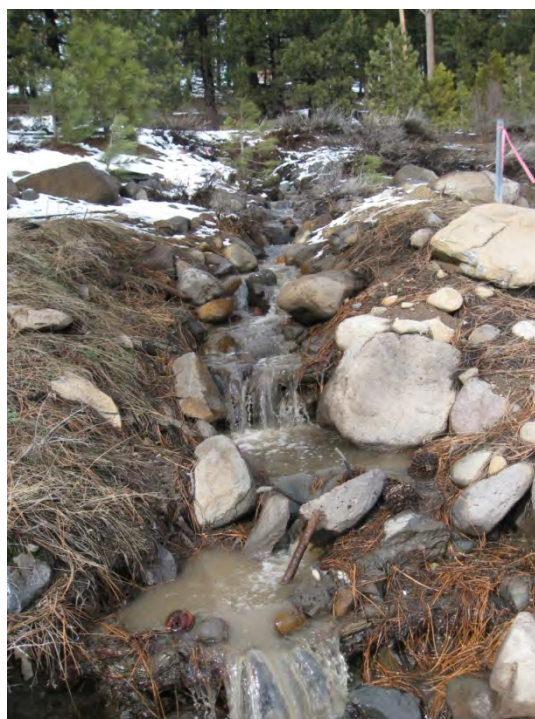
Five samples have been collected to date. The mean TSS concentration at this site was in the intermediate range when compared to other sites. When comparing this site to only the new Town sites, it had the lowest mean TSS concentration which was unexpected due to the surrounding land uses. It is possible that with additional sampling, a more representative dataset could show higher TSS concentrations at this location. Field observations have indicated large sediment loads entering Trout Creek at this location.

**Figure 5-44**  
**Steep Channel above Trout Creek NW Site**

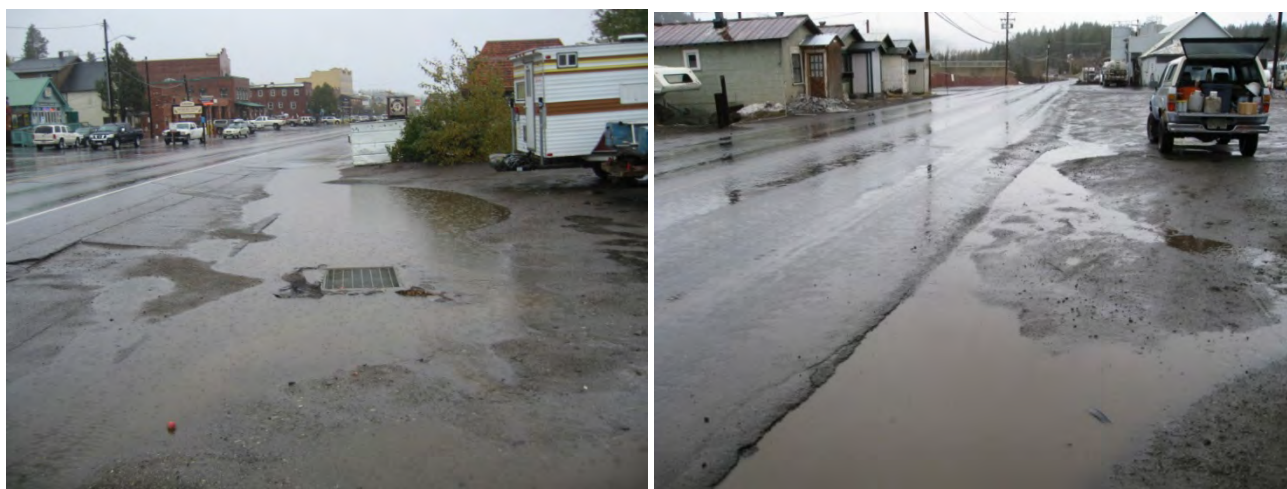
The Brickelltown site had higher mean values of TSS, turbidity, total phosphorus, and total nitrogen than all of the other community level sites. The Brickelltown drainage area represents older development with high imperviousness and little or no water quality controls. It also includes multiple high traffic roadways and unpaved parking lots that are directly adjacent to the drainage inlets (Figure 5-45). These roads receive frequent traction sand applications during winter months and vehicle traffic tracks additional road sand from Interstate 80 as well as from pulling in and out of the unpaved parking areas. Snow removal operations frequently disturb soils which later erode during snowmelt or stormwater runoff events. This site also has trace levels of petroleum hydrocarbon contamination based on visual observations of sheen and the results of a grab sample collected during WY 2011. No groundwater intrusion has been observed coming into the drainage system at this site.

**Figure 5-45**  
**Runoff from Unpaved Parking Lots in Brickelltown Catchment Area**

In November of 2011 the drainage system upstream of the sampling point was cleaned by Town maintenance crews. Four samples were collected at the site after the cleaning operations which did not indicate a clear improvement in water quality but this may be due to the limited amount of data.

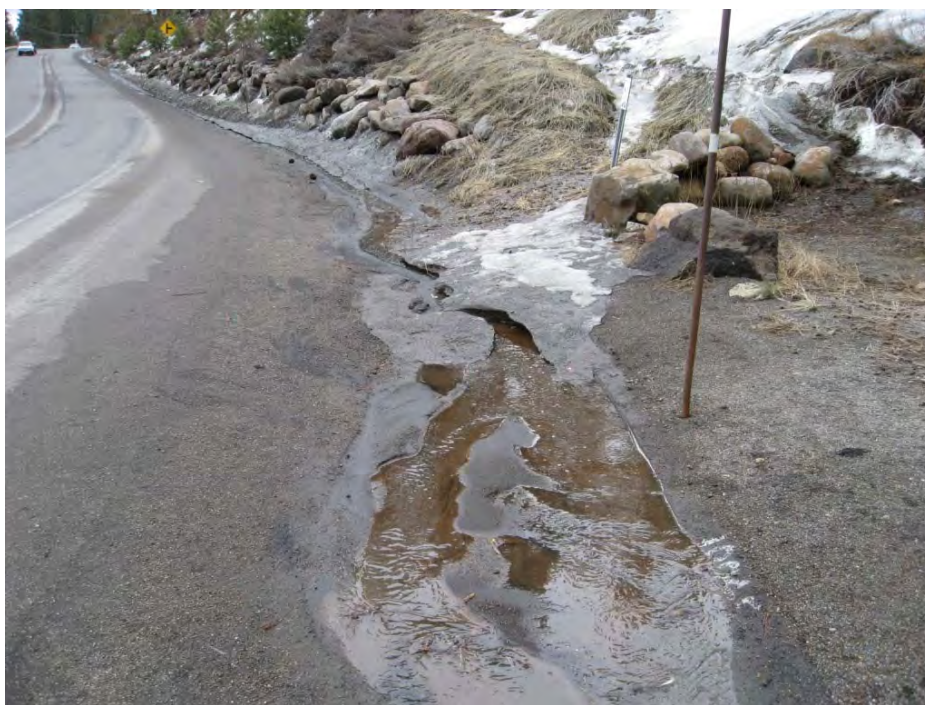
This site was installed in March 2012 and monitored for TSS, turbidity, pH, and conductivity only. TSS was laboratory analyzed, but the other constituents were measured using field instruments. Five samples have been collected to date. The mean TSS concentration measured at this site was higher than most of the community level sites. Runoff for this site originates from Brockway Road and the Hilltop development. A spring also discharges into the drainage area which likely dilutes the runoff being sampled at this site. Traction sand is frequently applied to this portion of Brockway Road and erosion is occurring on the cut slope above the site as shown in Figure 5-46. The results at this site were highly variable ranging from 26 mg/L to 1400 mg/L, both of which were from mixed rain and snow events. In this case, the higher concentration was from a larger precipitation event (1.8 inches versus 0.8 inches).

**Figure 5-46**  
**Sediment Accumulations on Brockway Road Draining to DSC-TT2**

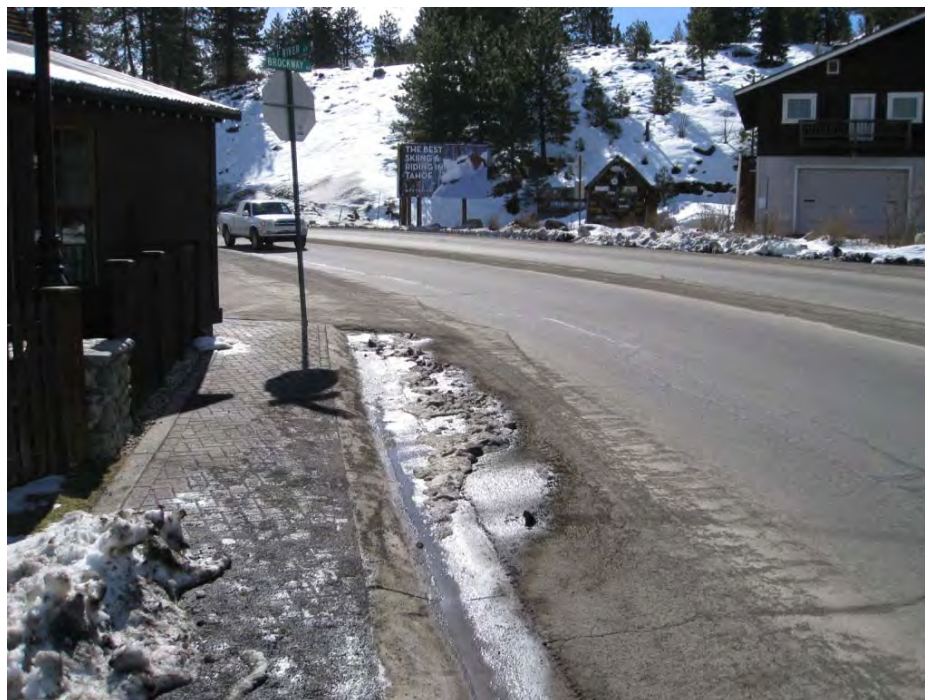
This site was installed in March 2012 and monitored for TSS, turbidity, pH, and conductivity only. TSS was laboratory analyzed, but the other constituents were measured using field instruments. Five samples have been collected to date. This site had the third highest TSS mean concentration after the Donner Creek and Brickelltown sites. This site has a small drainage area consisting of a section of Brockway Road that receives significant amounts of traction sand during the winter months as shown in Figure 5-47. A large stormwater vault just upstream of the sampling point provides treatment prior to discharge. Small runoff events typically do not discharge from the outfall as a result of this vault. A very high TSS concentration was observed during an April 12, 2012 snowmelt event, and a low value was observed during an August 14, 2012 rain event. This was likely due to the amount of traction sand present on the roadway at the time of the event.

**Figure 5-47**  
**Sediment Accumulations on Brockway Road Draining to DSC-TT3**

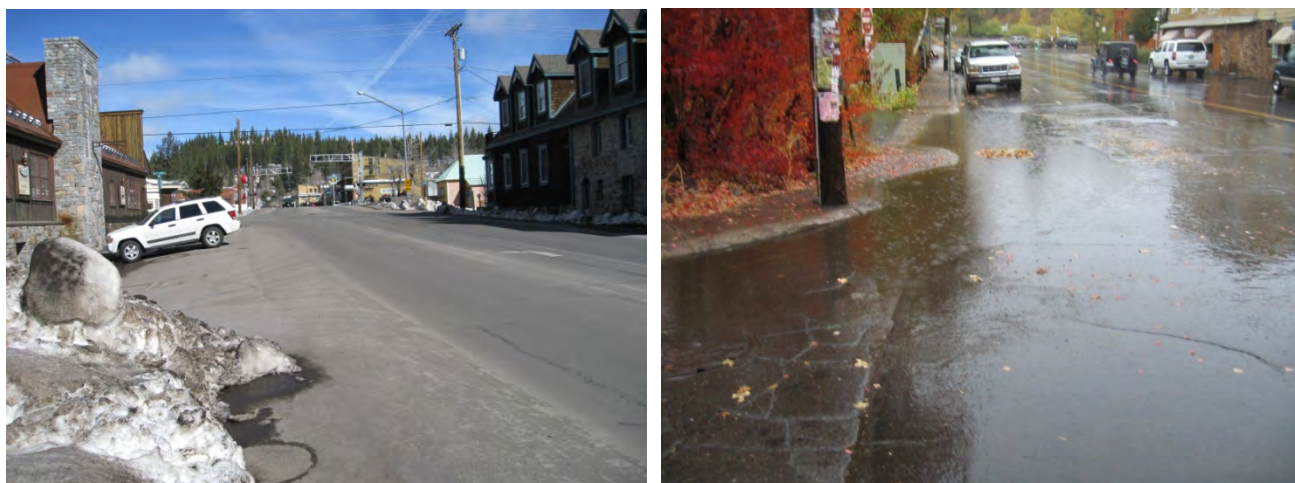
This site was installed in March 2012 and monitored for TSS, turbidity, pH, and conductivity only. TSS was laboratory analyzed, but the other constituents were measured using field instruments. Five samples have been collected to date. The mean TSS concentration at this site was in the middle of the range when compared to all other sites. This site receives runoff from historic downtown Truckee with little upstream stormwater treatment. The results at this site were also variable ranging from 50 mg/L to 1000 mg/L, both for snowmelt events. A photograph of the downtown drainage area during a rain event is provided in Figure 5-48.

**Figure 5-48**  
**Catchment Area Draining to the Bridge Street NW Outfall (DSC-TT4)**

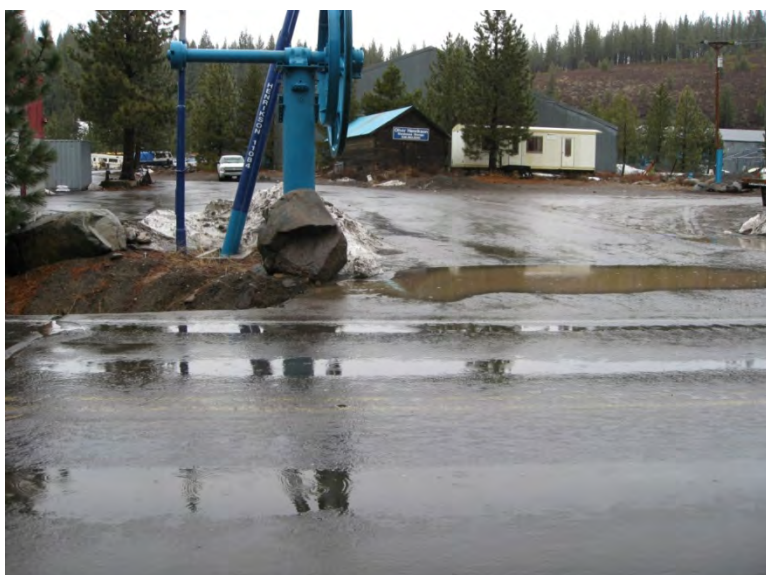
This site was installed in March 2012 and monitored for TSS, turbidity, pH, and conductivity only. TSS was laboratory analyzed, but the other constituents were measured using field instruments. Five samples have been collected to date. The mean TSS concentration at this site was in the middle to high range Relative to other sites. It receives runoff from commercial areas on West River Street as well as from West River Street itself. The commercial areas contain a large area of dirt open space that appears to be a major source of TSS at this site (Figure 5-49). The runoff from West River Street is conveyed to the outfall via an earthen channel where erosion is evident as shown in Figure 5-50. The culvert crossing under the road at this site is approximately 50 percent full of sediment. The two samples with the highest TSS concentrations at this site were from snowmelt events.

**Figure 5-49**  
**Catchment Area Draining to the West River Street Outfall (DSC-TT5)**

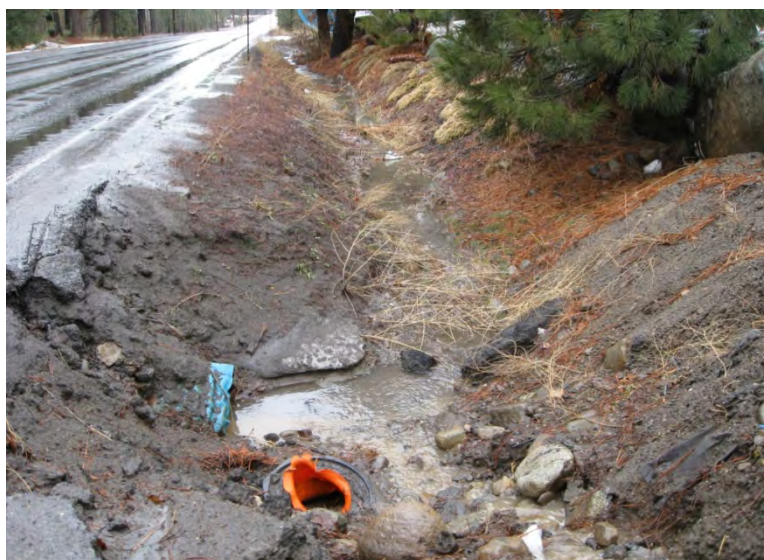
**Figure 5-50**  
**Earthen Channel Upstream of the West River Street Outfall (DSC-TT5)**

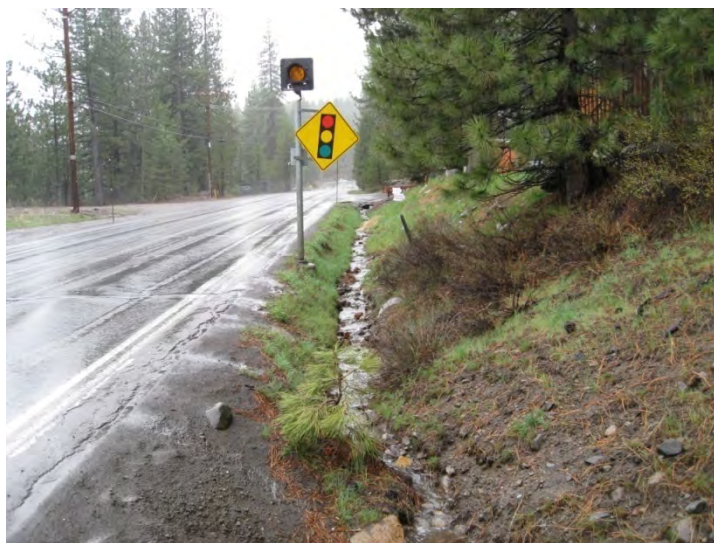
This site was installed in March 2012 and monitored for TSS, turbidity, pH, and conductivity only. TSS was laboratory analyzed, but the other constituents were measured using field instruments. Five samples have been collected to date. This site had the second highest mean concentration of TSS after Brickelltown. This was the only site not to have a single event concentration below 100 mg/L. The drainage area for this site includes a section of Highway 89, West River Street, and a portion of the Donner Creek Trailer Park. This is a very high traffic area that receives traction sand treatment during winter storms. Runoff is conveyed to the site via an earthen channel which shows signs of erosion (Figure 5-51). This site discharges to Donner Creek just above the confluence with the Truckee River. A sediment plume is often visible at this confluence (Figure 5-52).

**Figure 5-51**  
**Earthen Channel Leading to the Donner Creek Outfall**

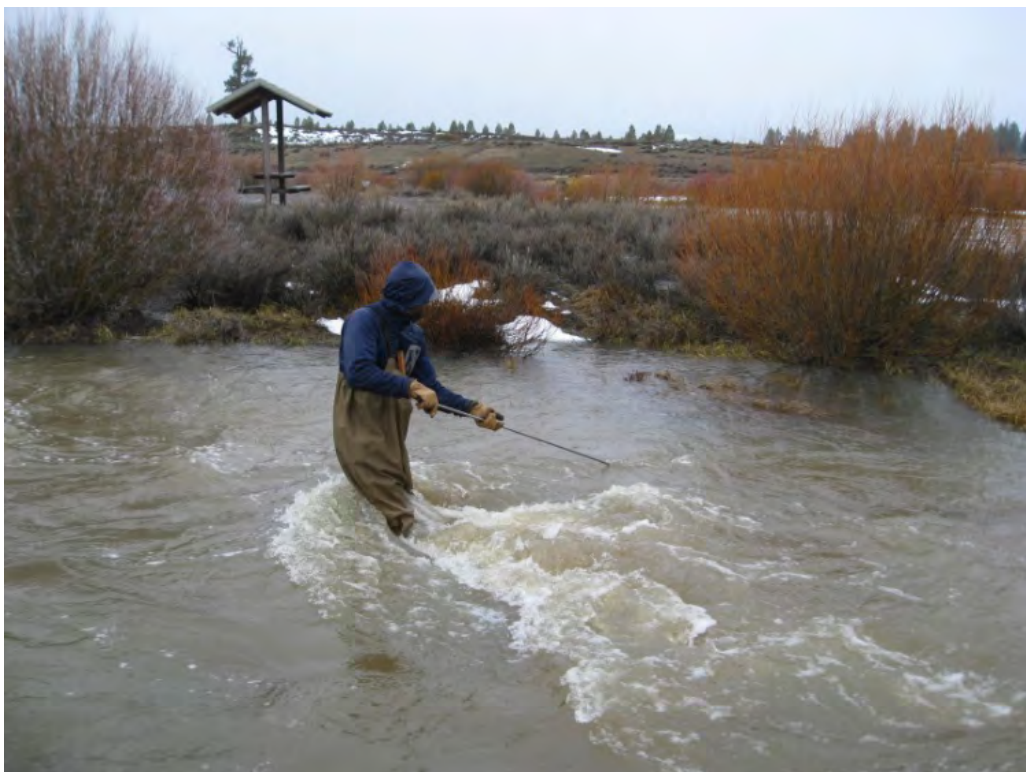
**Figure 5-64**  
**Sampling at Site DST-MC1**

This monitoring site is located at the mouth of Martis Creek, and is downstream of all tributary confluences. The larger flows produced by rain and mixed events at this site (Figure 5-64) produced the highest concentrations at this location relative to the smaller snowmelt induced flows. This site had the highest levels of TSS and turbidity and the concentrations of TKN, total nitrogen, and total phosphorus were all in the higher range when compared to the other tributary sites. The mean concentrations of TKN and total phosphorus exceeded the established water quality objectives at this location while the total nitrogen concentrations were below the water quality objective.

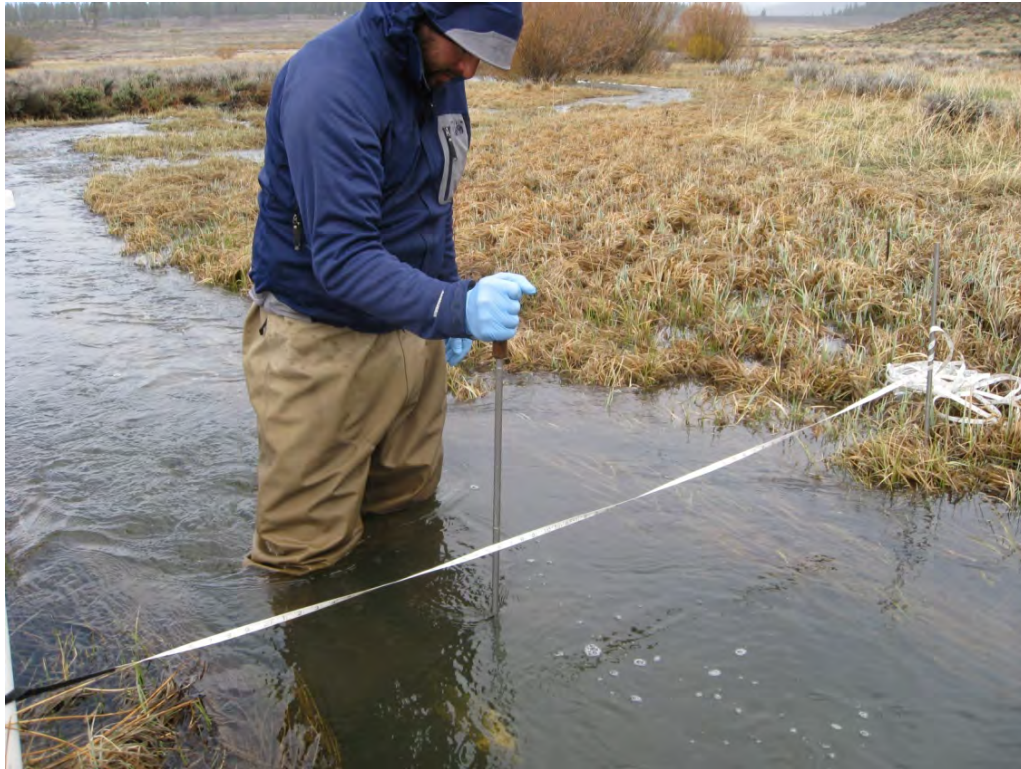
**Figure 5-65**  
**Sampling at the DST-MC2 during 4/26/12 Rain Event**

This site is located on East Martis Creek approximately 0.5 mile upstream of its confluence with the main stem. The sub-watershed for this site consists of 100 percent pervious, upland meadow and forest with some dirt roads. This site had the lowest mean concentrations for TKN and total nitrogen and the second lowest mean concentration of total phosphorus. The mean TSS and turbidity concentrations at this site ranked in the middle to higher levels when compared to the other sites. The higher particulate concentrations at this site are somewhat unexpected given the minimal development in the sub-watershed. A photograph of sampling at this site is presented in Figure 5-65.

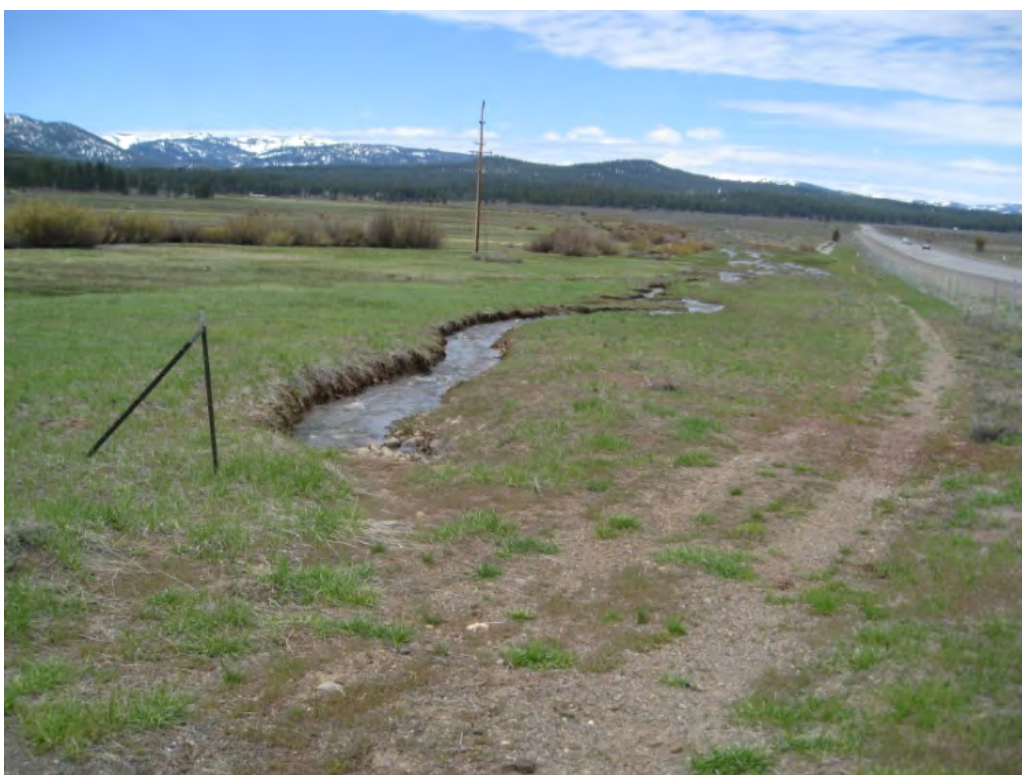
**Figure 5-66**  
**Middle Martis Creek Bypass**

This monitoring site is located on Middle Martis Creek approximately 250 feet upstream of its confluence with the main stem. The sub-watershed for this site consists of upland forest and meadow with some dirt roads as well as an approximately four mile section of SR 267. This portion of SR 267 includes a steep grade to Brockway Summit where traction sand is applied. Caltrans installed a series of new sand traps on SR 267 prior to WY 2012. During the spring snowmelt, the stream sometimes overtops its banks upstream of the monitoring location and a portion of the stream flow bypasses the site (Figure 5-66). During this time period, flows travel along preferential paths formed by previous overflow conditions at this location. Most of the flow from the breach returns to the main channel upstream of the monitoring site, but some flows into the main stem of Martis Creek just downstream of the monitoring location. The mean concentrations of TSS, turbidity, TKN, and total phosphorus were all in the mid to higher levels relative to other tributary level sites.

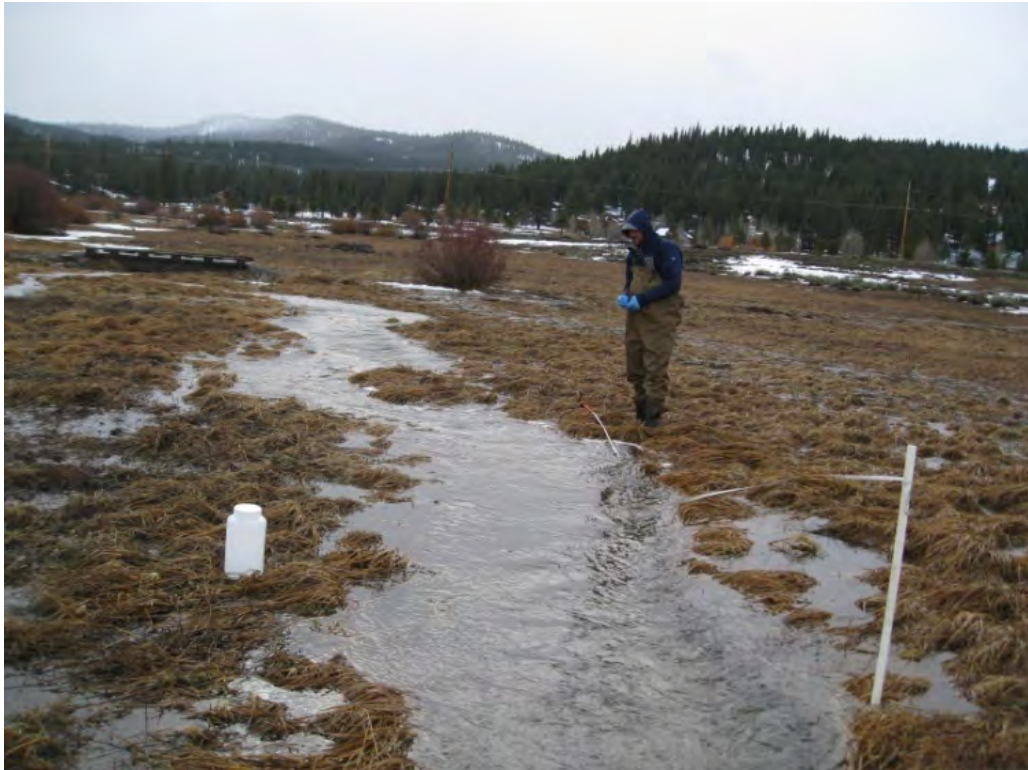
**Figure 5-67**  
**Site DST-MC4 Looking Upstream Towards Golf Course and Northstar**

DST-MC4 is located on West Martis Creek approximately 0.25 miles upstream of its confluence with the main stem. West Martis Creek originates within the Northstar ski resort and flows through the Northstar residential development and golf course (Figure 5-67). The mean concentrations of TSS, turbidity, TKN, total nitrogen, and total phosphorus were all in the mid to higher levels when comparing this site to the other tributary sites.

observed at this site. This outfall, and others in the Northstar community that discharge into West Martis Creek, are likely contributing to the higher fine sediment percentages observed in the RAM and elevated TSS levels at site DST-MC4.

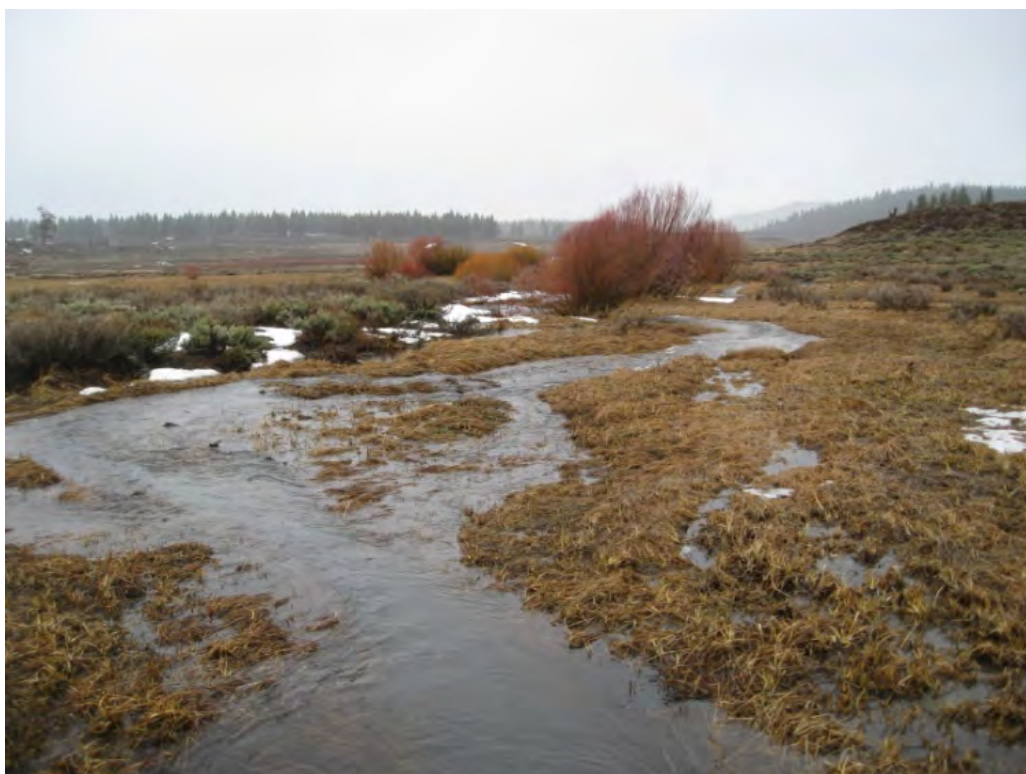
**Figure 5-68**  
**Unnamed Tributary Breaching its Banks near Site DST-MC5**

This site is located on the main stem of Martis Creek approximately 100 feet downstream of an unnamed tributary that receives flow from a portion of the Lahontan development and access road. This site was relocated downstream following the first monitored event in 2011 due to a breach in the unnamed tributary that caused a significant portion of the flow to bypass downstream of the original monitoring location (Figure 5-68). This site is located upstream of all major tributary confluences, and its sub-watershed consists of a portion of the Northstar ski resort, upland forest and meadow with some dirt roads, and the developed residential areas of Lahontan Golf Club and Martis Camp. This site has a large sub-watershed and receives more flow than the other tributary sites (except for DST-MC1). This site had the second lowest mean concentration for TSS, turbidity, and TKN. The mean concentration for total phosphorus went from the lowest value in WY 2011 to the highest value in the combined WY 2011 and WY 2012 data. This increased average is likely due to a mix event on January 21, 2012 and a rain event on April 26, 2012 which produced total phosphorus concentrations at this site of 214 and 665  $\mu\text{g/L}$ , respectively, each much higher than any WY 2011 events.
