# Placer County/Town of Truckee

## Final Joint Annual Monitoring Report for:

### Implementation of the Truckee River Water Quality Monitoring Plan

Water Year 2012

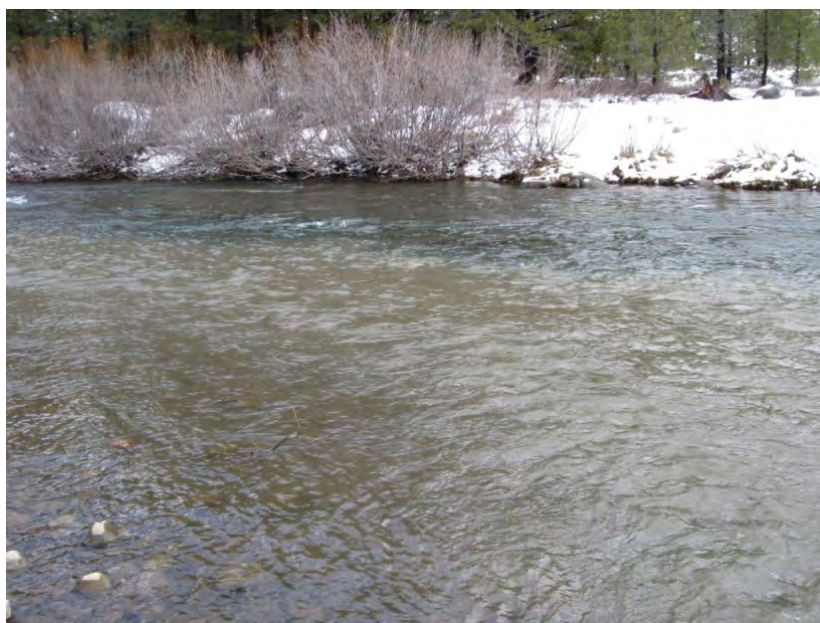
**Figure 6-1**  
**Sediment Plume in Truckee River from Donner Creek**

The monitoring assessment types conducted in the Town of Truckee corridor include RAM and community level water quality monitoring. RAM monitoring took place on Donner Creek, Trout Creek, and prioritized locations of the Truckee River. The results of the Truckee River RAM did not indicate high percentages of fine substrate despite a very high percentage in Trout Creek and elevated TSS concentrations at the community level monitoring sites discharging into the Truckee River throughout the downtown corridor. Trout Creek had the highest fine sediment percentages of all stream segments where rapid assessments took place. The results of the Donner Creek RAM did not indicate high percentages of fine substrate despite the turbid flows that were sometimes observed, likely due to the higher energy flows in this segment of Donner Creek. The two photographs in Figures 6-1 and 6-2 below show plumes of sediment entering the Truckee River from Donner Creek and site DSC-TT4 at Bridge Street.

The integrated results indicate that most fine sediment is discharged to the Truckee River from areas of high vehicle traffic where traction sand is used and is then transported downstream where it settles in lower energy reaches downstream and along the channel fringes where flows are slow.

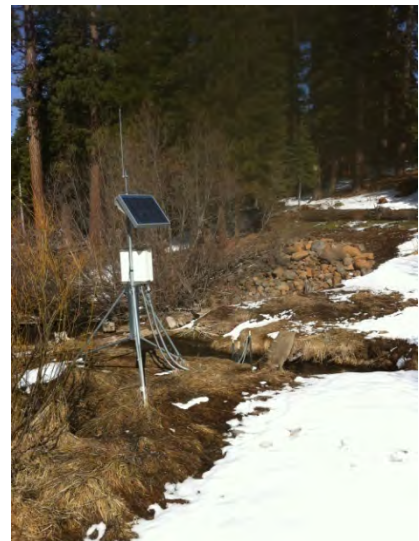
**Figure 8-1. Automated Water Quality Monitoring Stations in Placer County.**

The overall goal of these new turbidity stations is to provide a means of estimating suspended sediment loads that are occurring at the monitored locations. The following objectives have been defined for these stations to aid in focusing the data collection, analysis and reporting activities and to provide a means of measuring the progress and effectiveness of the monitoring activities:

1. Collect turbidity and total suspended solids (TSS) data at the sites and develop correlations between these two parameters.

2. Utilize available stream discharge data together with the turbidity: TSS correlation to calculate suspended sediment loads at the sites.
3. Integrate similar TRWC data into the overall analysis to characterize suspended sediment loads delivered to the Truckee River from Donner and Trout Creeks.
